Historic Preservation Commission Staff Report

Case #: HPC-52-25

Site Address: 2007 Maxie Thomas Way Parcel ID: 31-05-22-4-014-002.000

Proposed Work: Petition for a Certificate of Appropriateness for the removal of

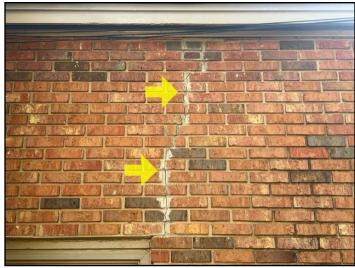
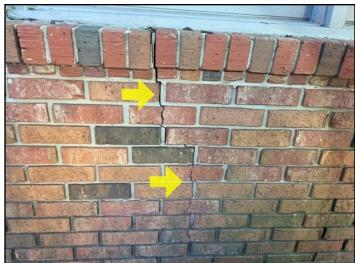
5. Condition: • Cracked

Significant cracks are noted at the right & left side brick veneer. There could be multiple reasons for the cracks, but I would assume the roots from the pecan trees are to blame. I recommend this tree be removed Implication(s): Chance of water damage to structure, finishes and contents I Weakened structure

Location: Right Side Exterior Wall

Task: Remove Trees **Time**: Immediate

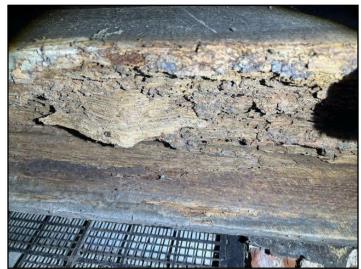
23. Insect damage

6. Condition: • Insect damage

Severe insect damage is noted at the right side beam that supports the entire wall. Similar damage is noted at the beam between the front room and the entrance to the left side hallway. This amount damage could lead to sagging floors and failing support structure. I recommend a structural engineer or general contractor for evaluation

Implication(s): Material deterioration
Location: Right Side Exterior Wall

Task: Further evaluation by a ST ENG/Contractor

Time: Immediate
