Historic Preservation Commission

Staff Report

Case #: HPC-31-26

Proposed Work: Petition for a Certificate of Appropriateness for the installation of a fence on the property located at 50 Sherwood Drive in the Sherwood Drive Historic District (Council District 4).

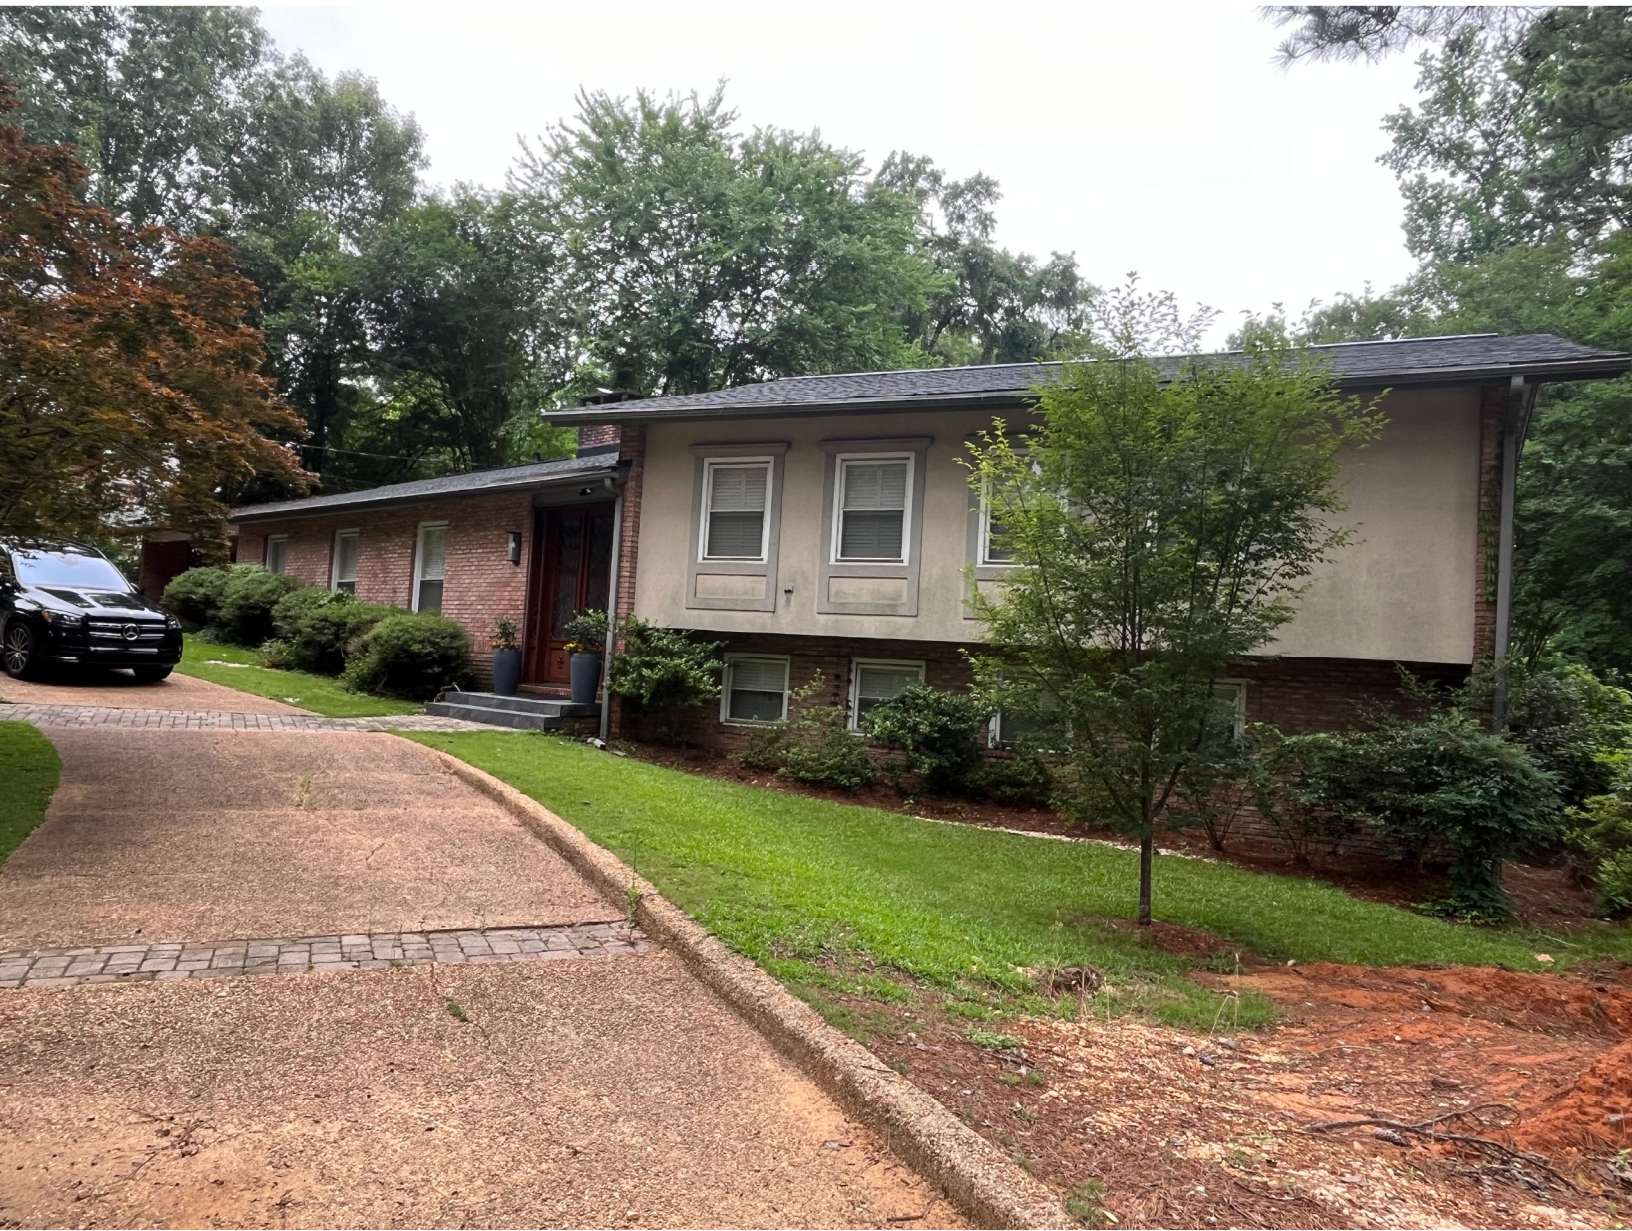
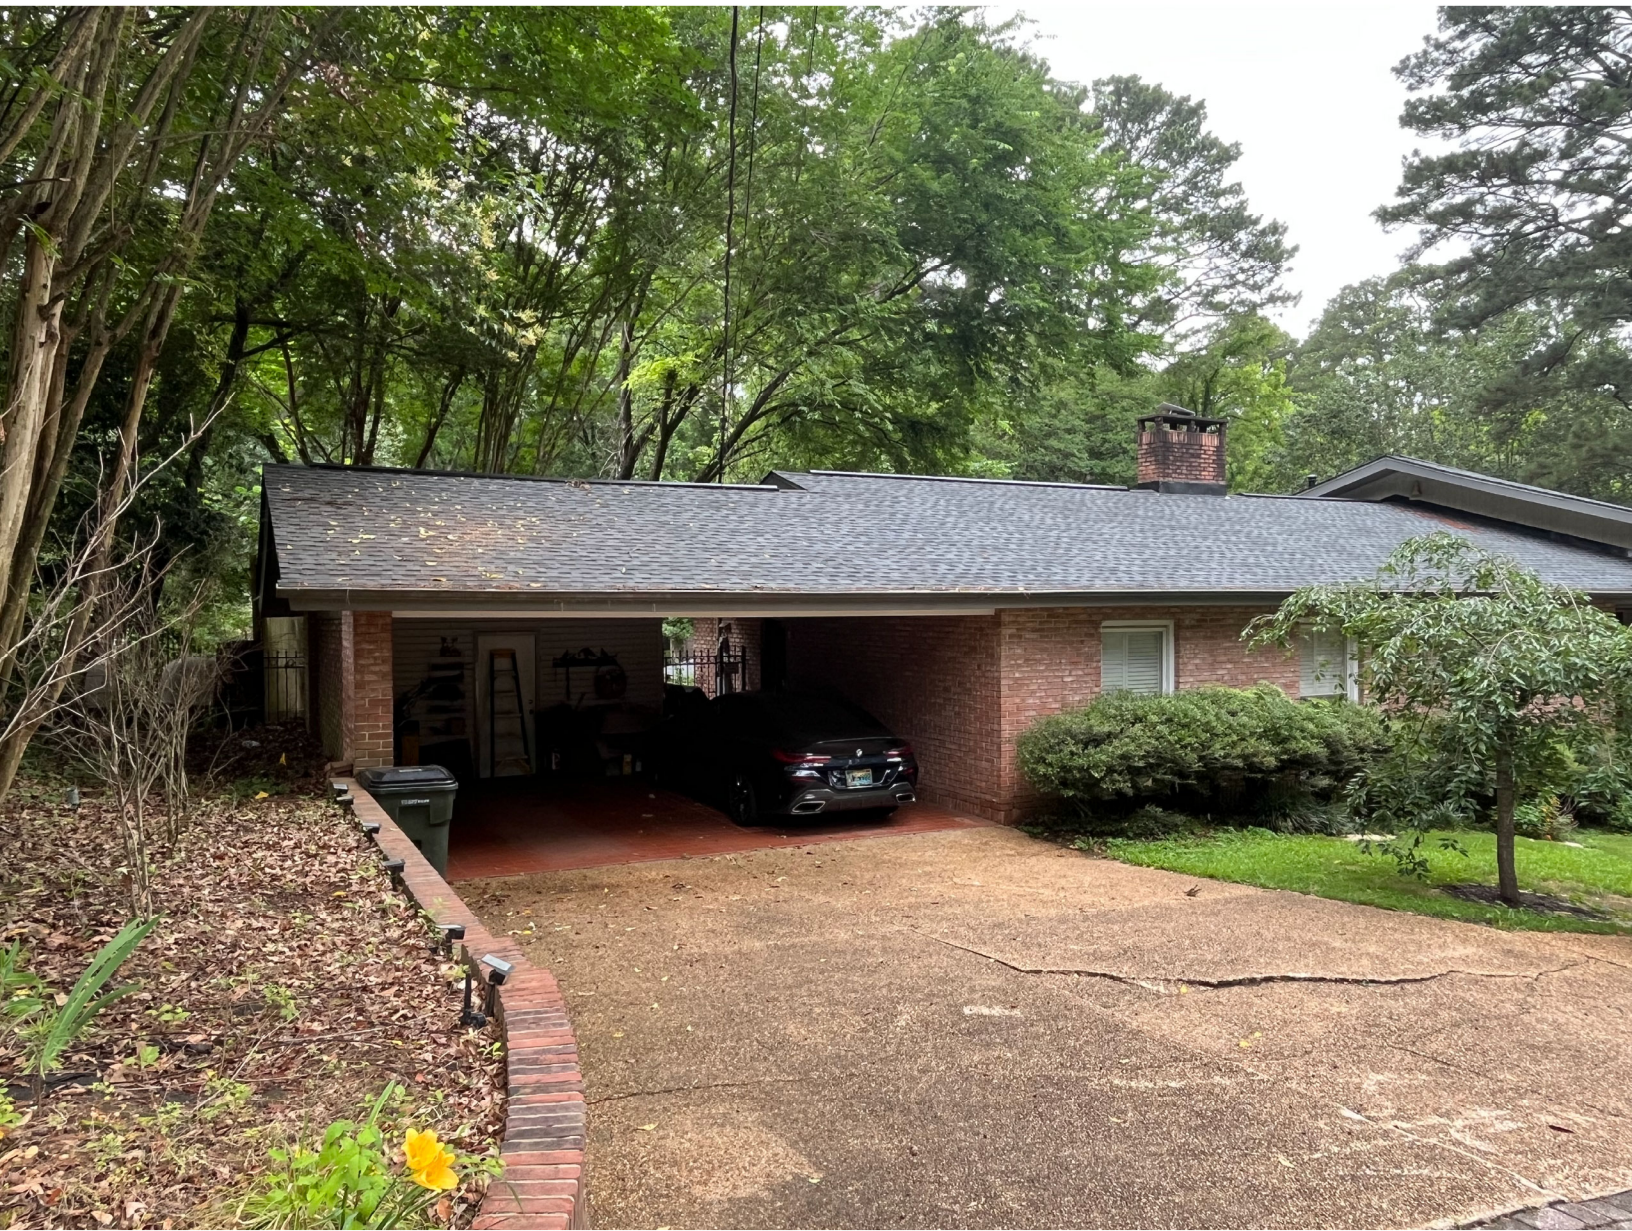
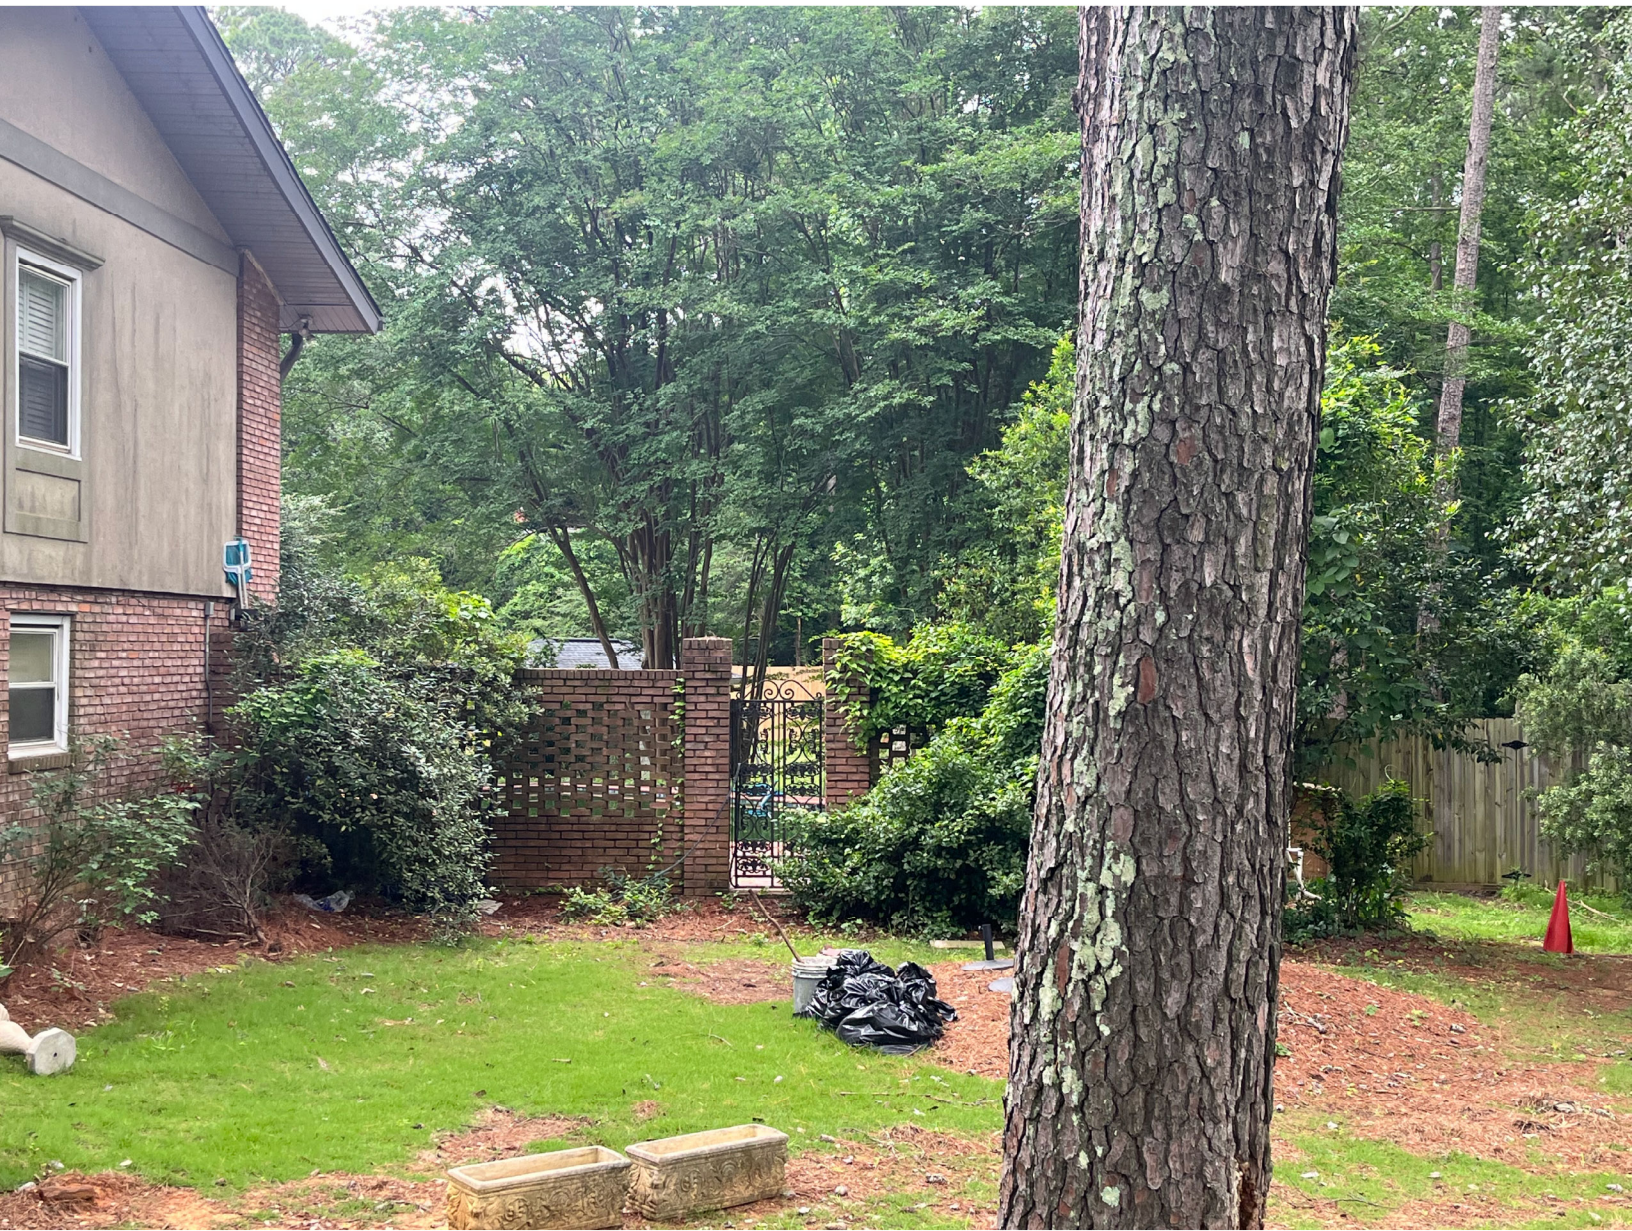
ADDITIONAL STAFF PHOTOS OF SUBJECT PROPERTY

Prior to the violation letter and a stop work order being placed, the petitioner constructed a 9' 8" tall fence surrounding the side and rear property lines of the subject property. The unfinished side of the fence is facing the exterior of the property.

Wood slat is listed as an appropriate material for fences per the Design Guidelines. Per the Design Guidelines, the owner should "present the finished side of all fences to the exterior of the property being fenced," and should "not exceed the average height of fences and walls of comparable type and location found on adjacent properties, generally not to exceed six (6) feet."

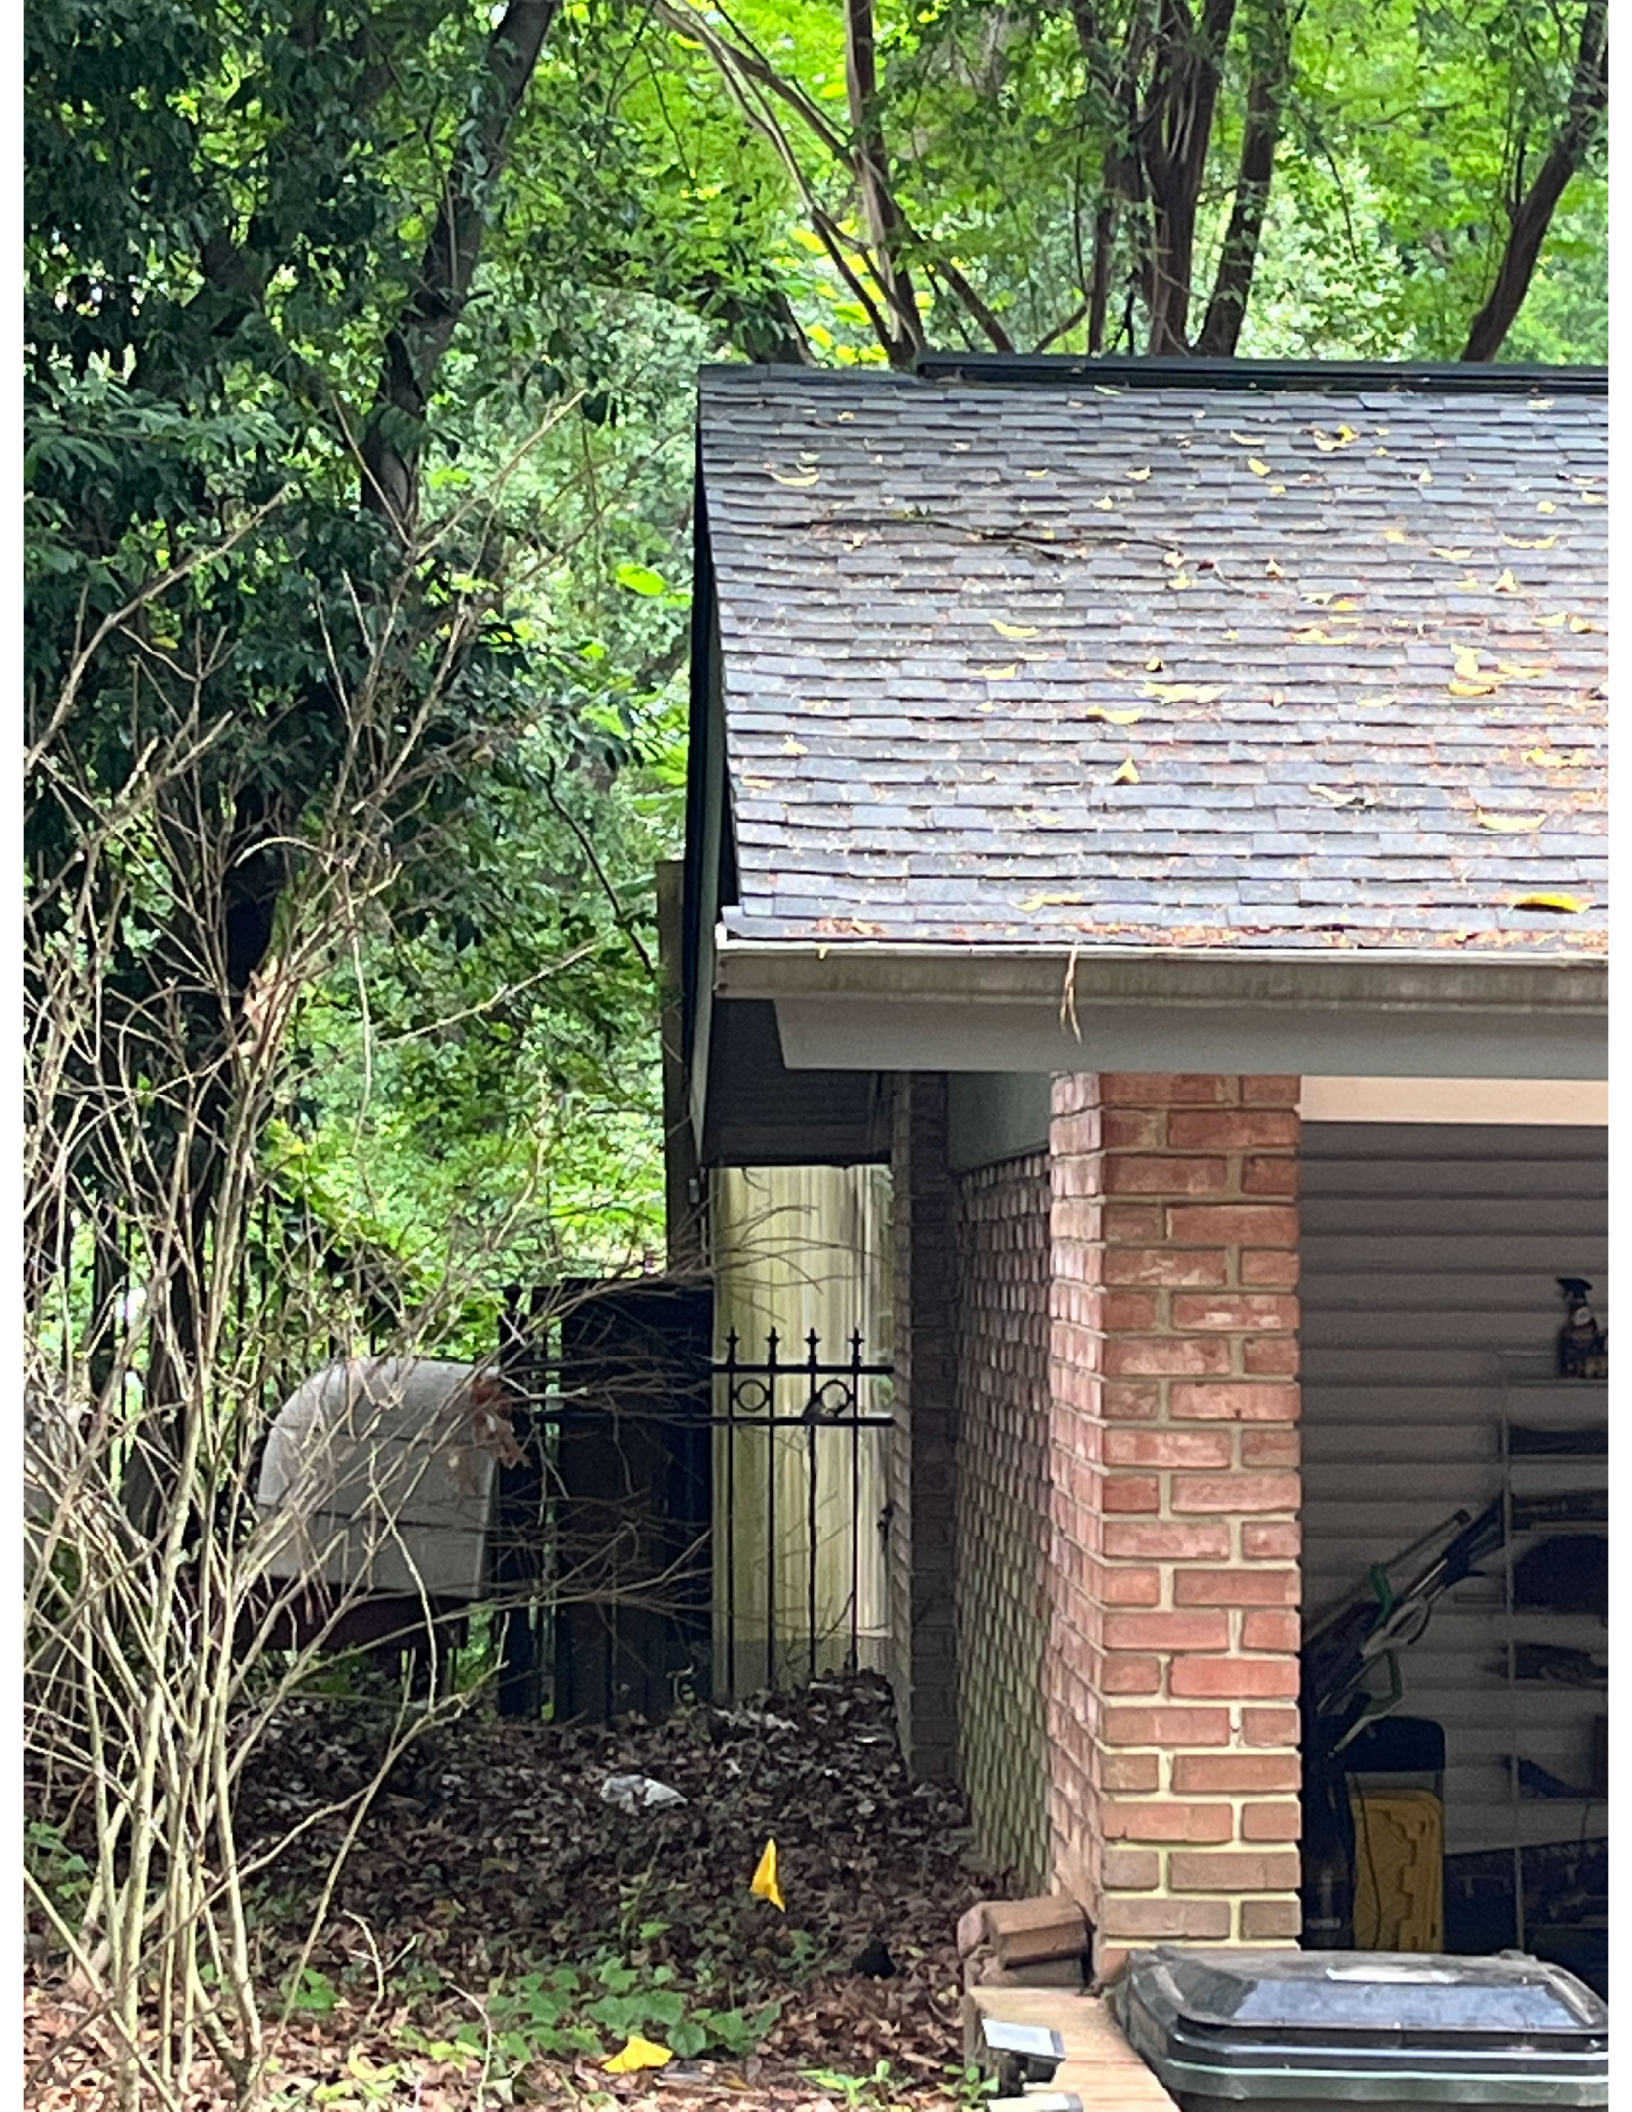
DO NOT REMOVE!
NOTICE
STOP WORK
BY ORDER OF
CITY OF TUSCALOOSA

Stop Work

Remarks Need Permit & Historic Council approval

Work May Be Resumed when permit is posted

Please See That Indicated Violations are Corrected Not Later Than Feb 24 26
